Upper Spey Embankment Condition Assessment

Final Report

Cairngorms National Park Authority

cbec eco-engineering UK Ltd

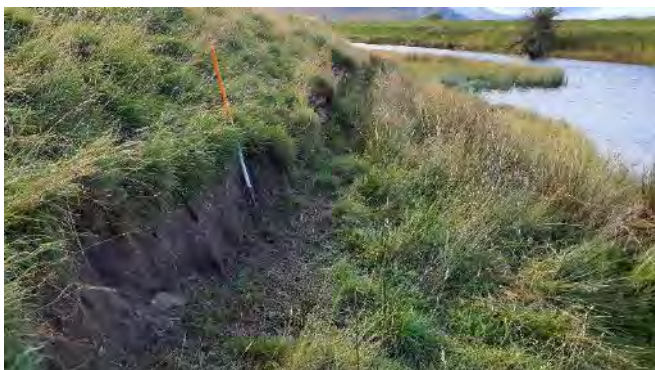
Figure 3.1. Low-severity riverbank erosion.

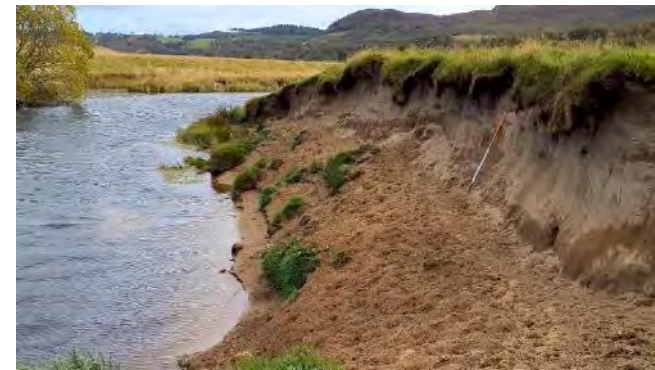
Figure 3.3. High-severity riverbank erosion.

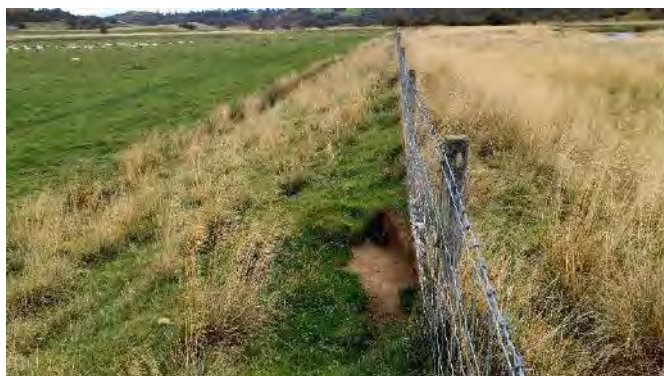
Figure 3.4 Low risk of embankment breach. Slumping of the embankment crest appears to have been caused by livestock trampling. The embankment is set back from the riverbank and signs of slumping observed are localised.

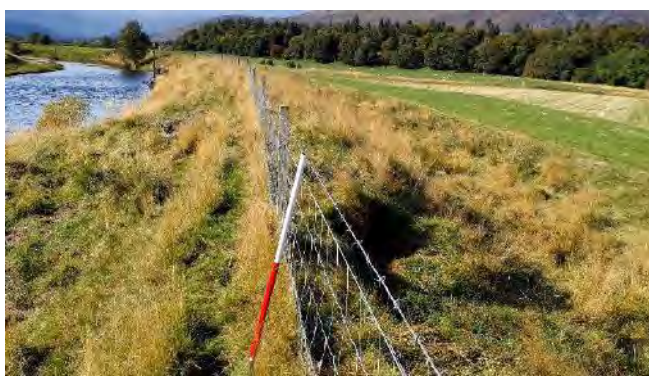
Figure 3.5 Moderate risk of embankment breach. Situated within 5 m of the riverbank, with slumping and bare ground exposed on the dry side of the embankment.

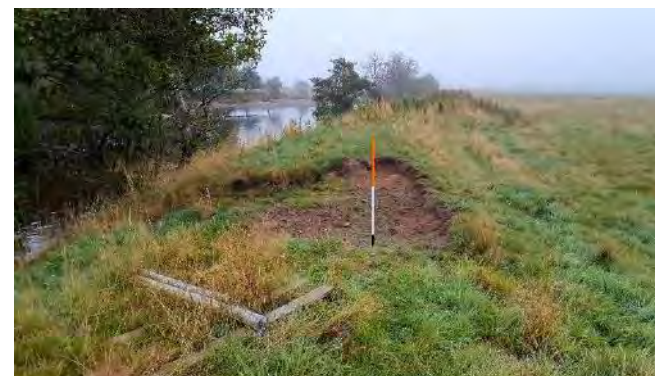
Figure 3.6 High risk of embankment breach. Embankment positioned along the top of the riverbank. Bare ground and slumping evident across over half of the embankment crest width.

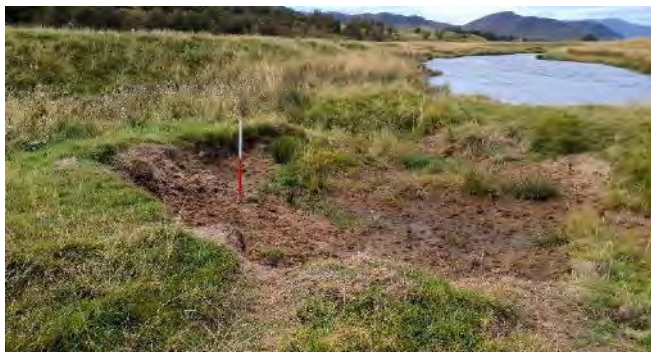
Figure 3.7. Livestock trampling across the riverbank, leading to soil erosion and loss of surface vegetation.

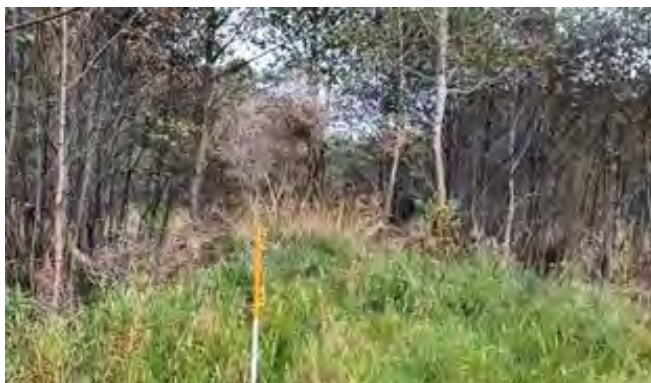
Figure 3.10 Young tree growth and regeneration across the crest and face of an embankment.

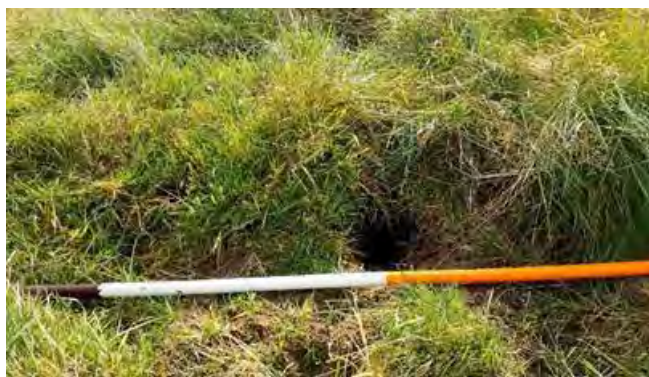
Figure 3.11 Burrow within the crest of an embankment. Mole hills and burrows were occasionally noted in Areas 1 and 2, but their position and density were insufficient to cause concern at the time of survey.

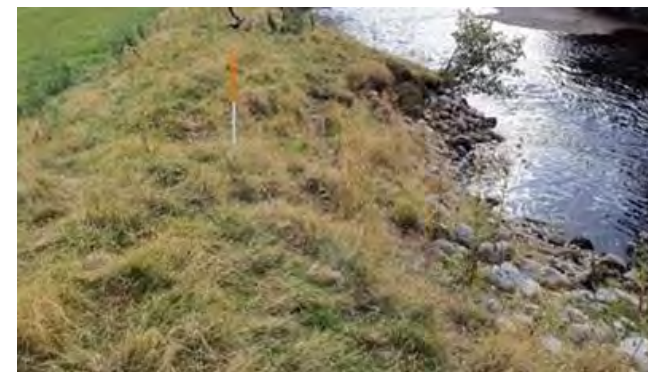
Figure 3.12 Riverbank erosion undermining an embankment positioned at the top of the bank. High risk of embankment breach.

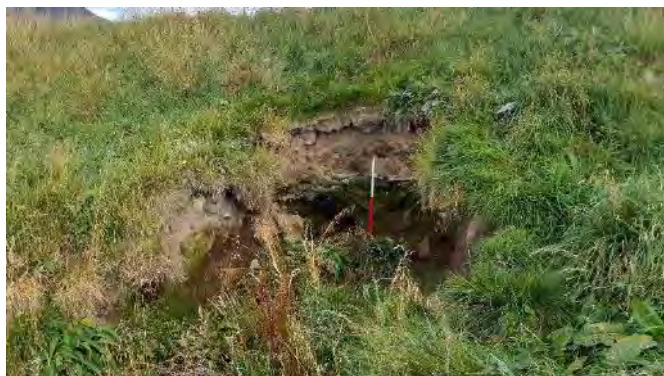
Figure 3.63 Culvert through the embankment with erosion around the inlet at Drumgask Farm (OS NGR NN 61927 94037).

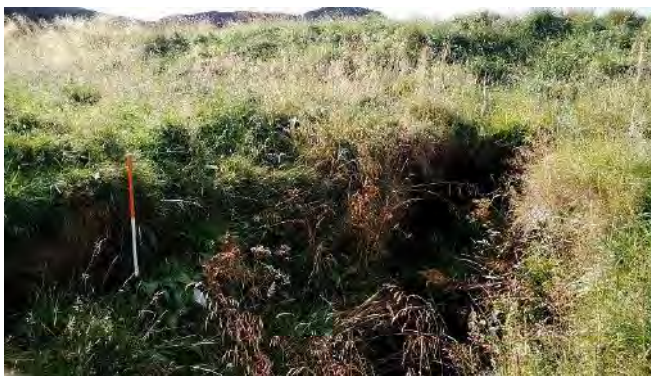
Figure 3.64 Culvert with erosion around the outlet at Drumgask Farm (OS NGR NN 61927 94037).

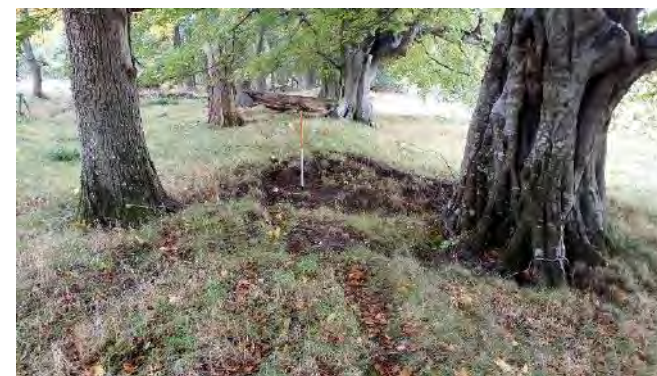
Figure 3.65 Example of mature trees growing on the embankment and erosion caused by sheltering livestock.
