2016/0195/DET and  
2016/0196/LBC

## Royal Station Renewal

### **DESIGN & ACCESS STATEMENT**

Prepared by Halliday Fraser Munro for Aberdeenshire Council

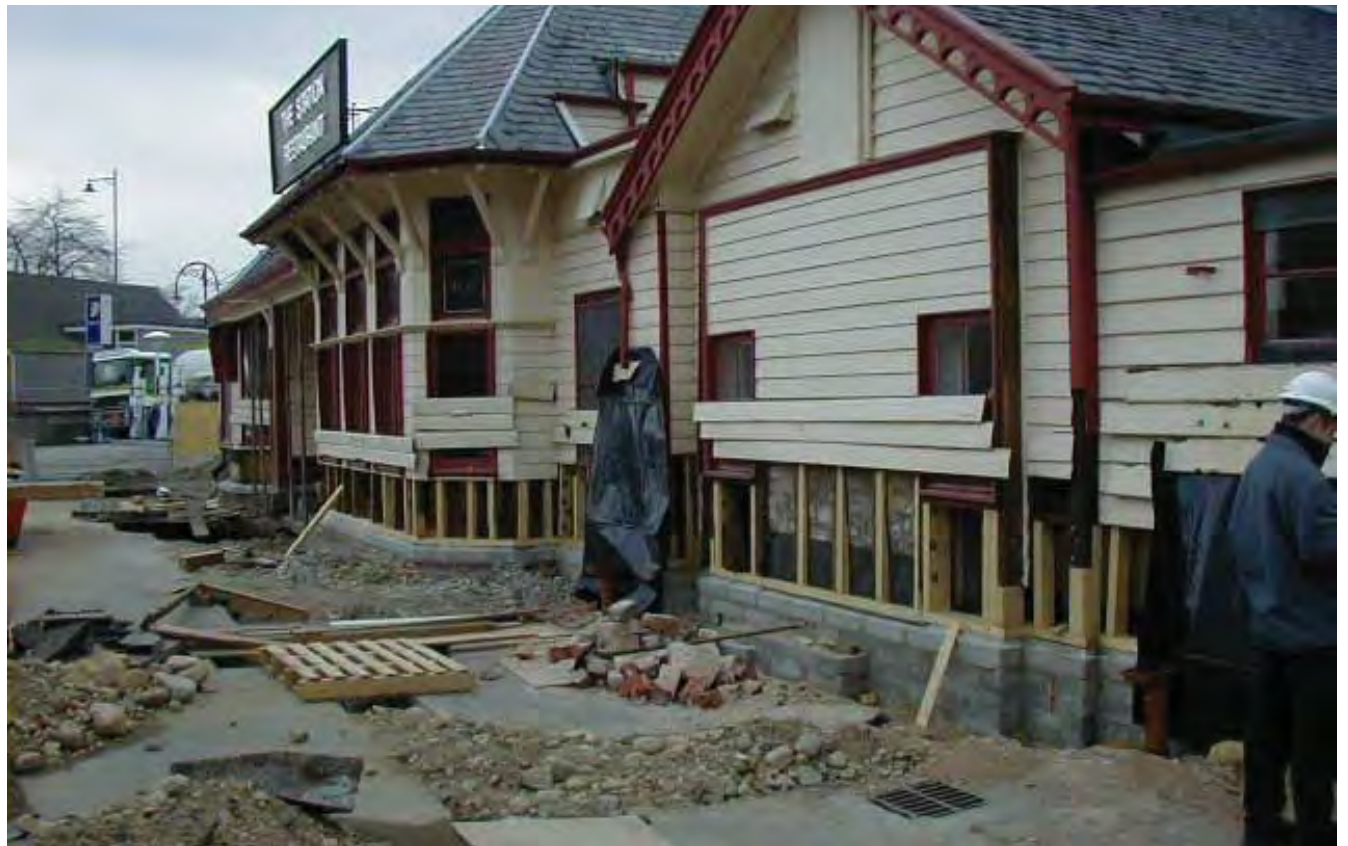
Aberdeenshire undertook extensive renovation works on the Royal Station with the focus on improvements to the underbuilding and internal layout. The works included a programme of propping of the entire building to provide a new underbuilding with insulated concrete floor slab. Internal refurbishment works were also completed to provide improved accommodation for Visit Scotland, The Station Restaurant and other small businesses. The construction of a new platform canopy with glazed infill created a new exhibition space which focused on the Royal connection, with the main attractions being Queen Victoria's Waiting Room and the replica Royal Carriage. Included in the restoration was replication of decorative wood panelling to Queen Victoria's Waiting Room.

Underbuilding work being carried out.

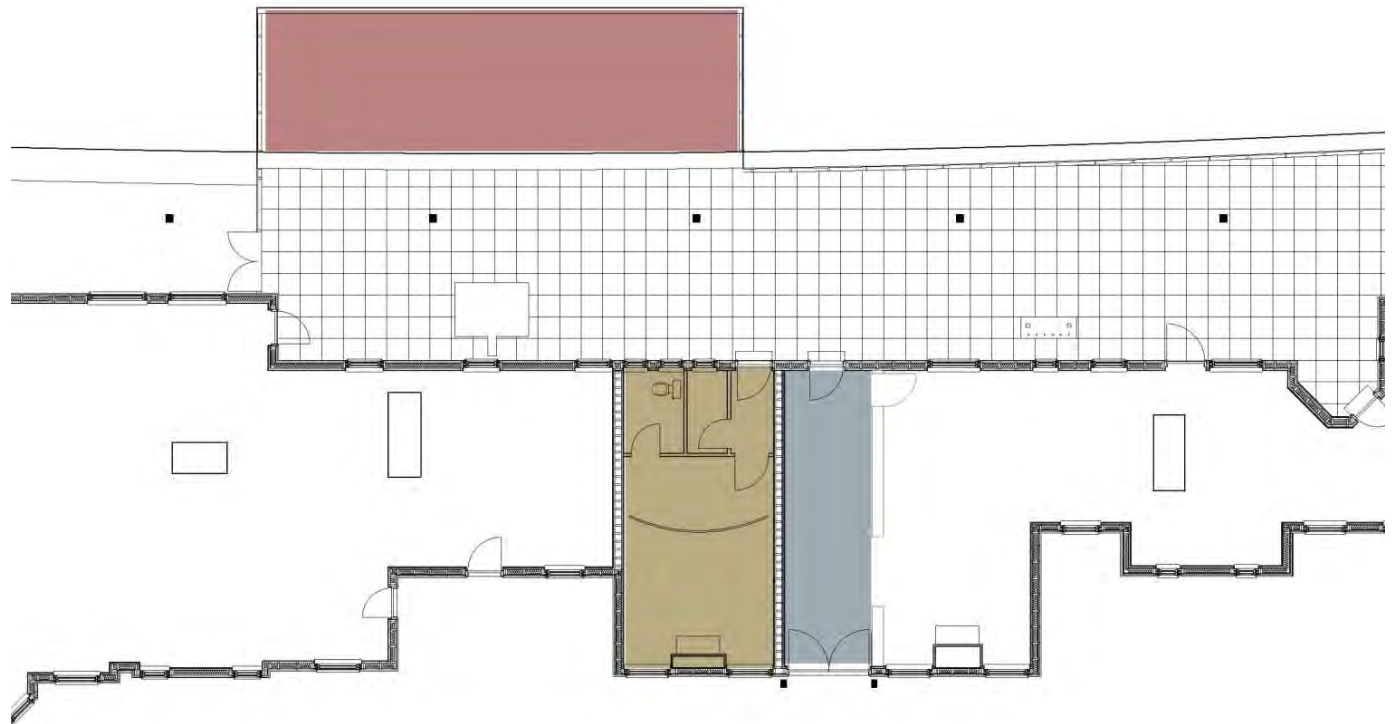
Plan Layout

Although the original building grew, with a number of extensions added and some elements removed both during and after its use as a train station, analysis and public feedback from Ballater Open Day highlighted the importance of three key elements within the building; the Royal Carriage, Queen Victoria's Waiting Room and the pend leading passengers out to Station Square.

-   Royal Carriage
-   Queen Victoria's Waiting Room
-   The Pend

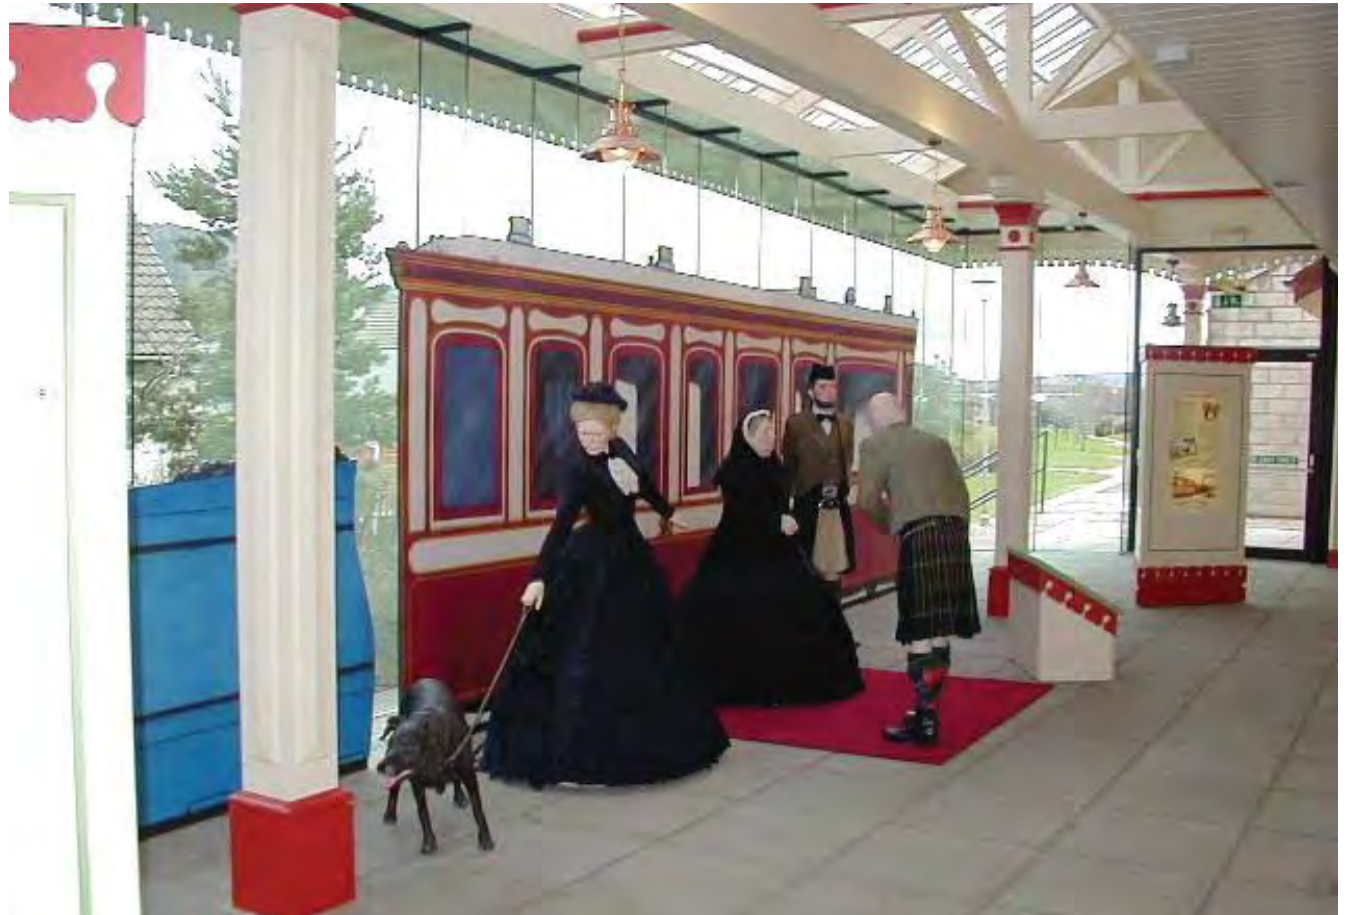
The exhibition space was formed by enclosing the existing platform with a new canopy and infilling the elevations with structural glazing. Analysis of this space from first hand accounts and photographic evidence identified that the exhibition suffered from poor lighting control, and lack of dedicated wall/exhibition space.

The view from the platform is also not representative of the Victorian era with a collection of small bungalows forming the backdrop to the exhibition. The expanse of glazing means that the views are uncontrolled and with light flooding into the space it creates a difficult environment for focusing attention on exhibits.

Exhibition Space circa 2000

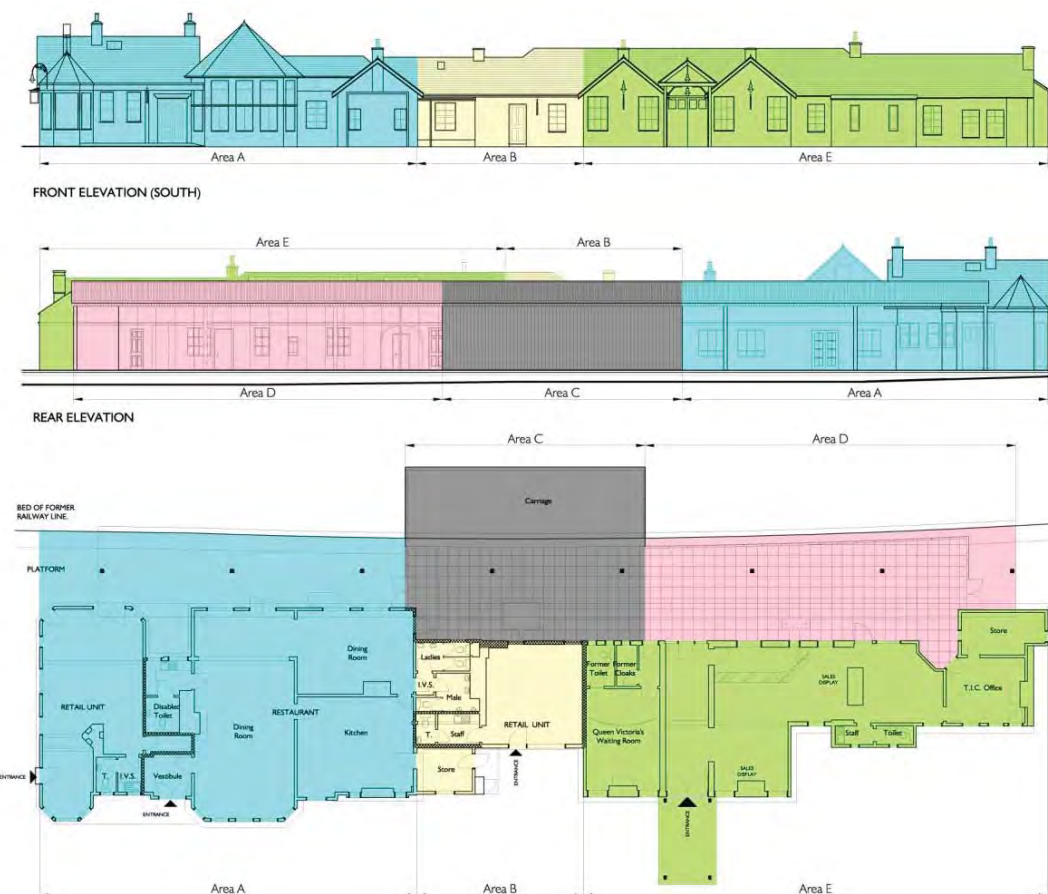
Post-fire Survey Drawing

The fire of May 2015 destroyed a large portion of the building. The following key and survey plan identify the condition of each area with photographs of the immediate aftermath.

**Area A** - Western end of original station previously accommodating retail unit, restaurant and kitchen - area is generally completely destroyed by fire with only part of restaurant vestibule and chimneys/fireplaces remaining.

**Area B** - Central retail unit and toilets/store to restaurant - area is generally destroyed internally along with total loss of roof structure, generally only external walls remain to front elevation.

**Area C** - Western end of platform canopy and display/exhibit area (including extension for royal carriage) - area is generally destroyed by fire with loss of original timber wall between platform and station building. Further, damage is evident to kingpost trusses, canopy roof lights and enclosing platform patent glazing. Trusses have deflected resulting to some instability for the roof structure with some temporary propping in place meantime.

**Area D** - Eastern end of platform canopy and display/exhibit area - trusses have suffered fire damage and charring at node points to original station structure with kingpost trusses deflecting. In addition there are a number of damaged panels to enclosing patent glazing along with fire damage to linings to underside of roof structure.

**Area E** - eastern end of original station accommodating royal waiting room and Visitor Information Centre - roof structure over these areas is totally destroyed with collapse into remaining areas. Waiting room has suffered extensive damage to decorative panelling and linings along with original stained glass windows. Remaining external wall structure generally appears intact, however fire damage is evident to wall heads and local areas of vertical linings. Partial damage to external horizontal linings is also evident either side of Porte Cochere.

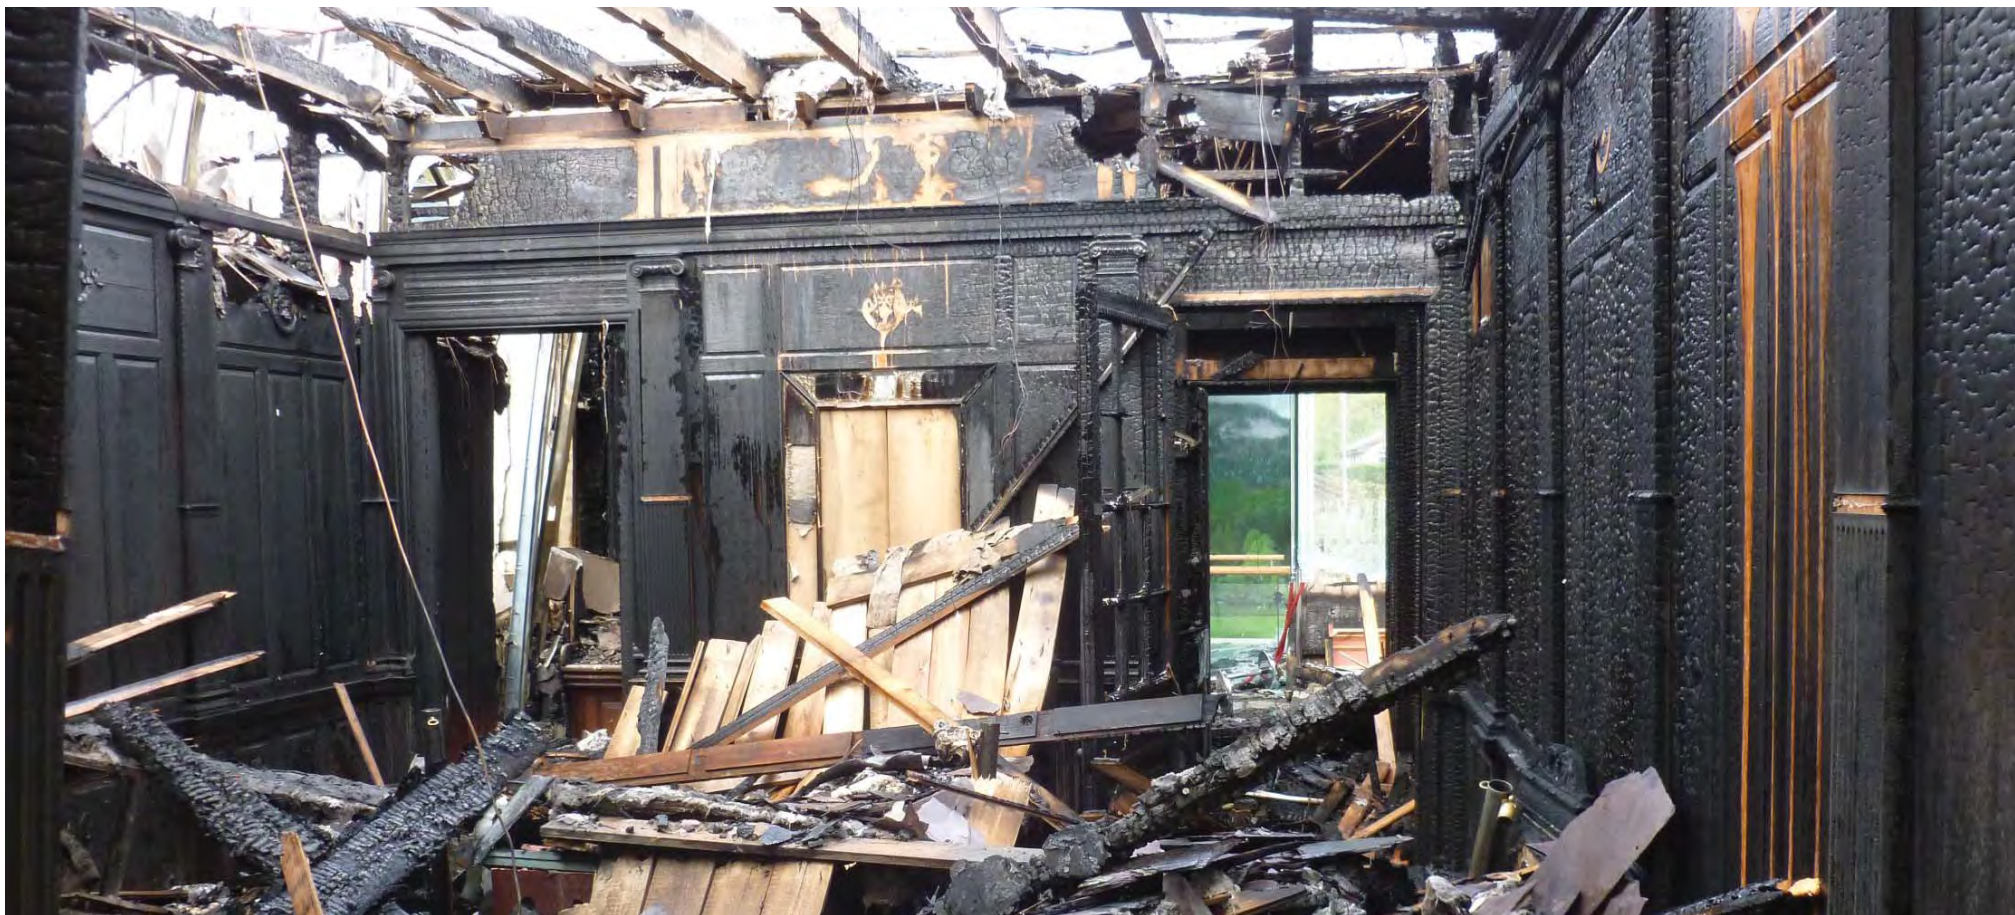
Queen Victoria's Waiting Room post fire

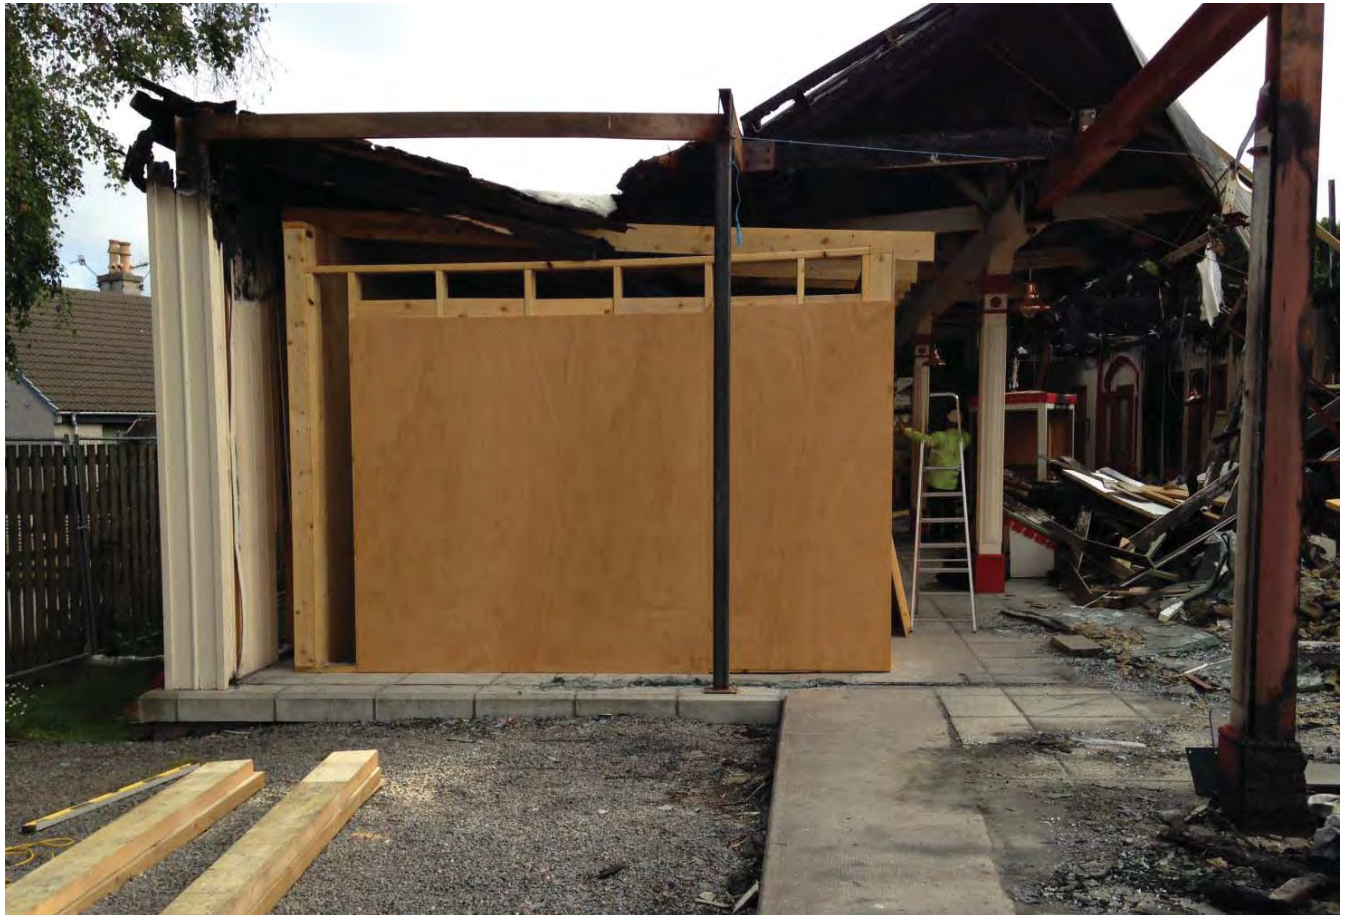
The royal carriage was saved by firefighters from fire damage. A temporary protective timber framed and ventilated enclosure has been erected around the carriage in order to protect it from the elements and help maintain its current condition.

Erection of Royal Carriage enclosure

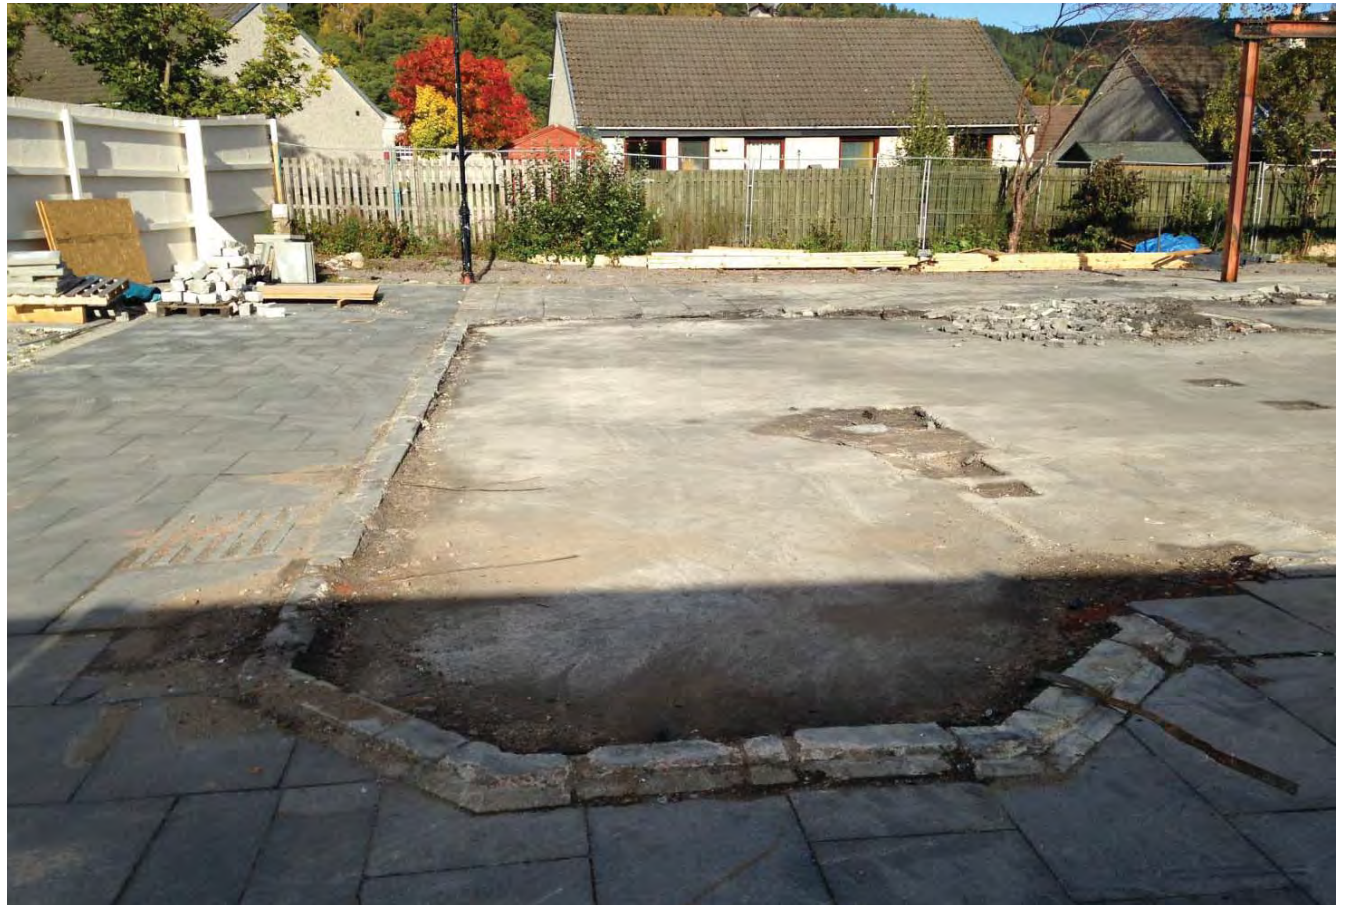
Clearance of the building debris revealed the concrete slab and foundations installed by Aberdeenshire Council as part of the 1999/2000 renovation. The footprints of the original chimney breasts, which were taken down for safety reasons, are still evident also.

Ballater Station Footprint

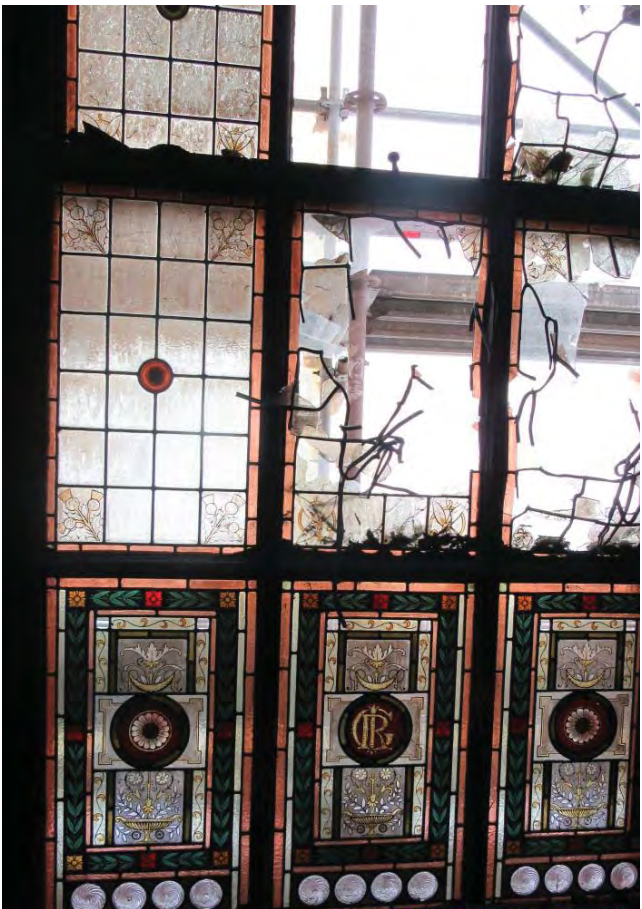
Stained Glass Window Condition

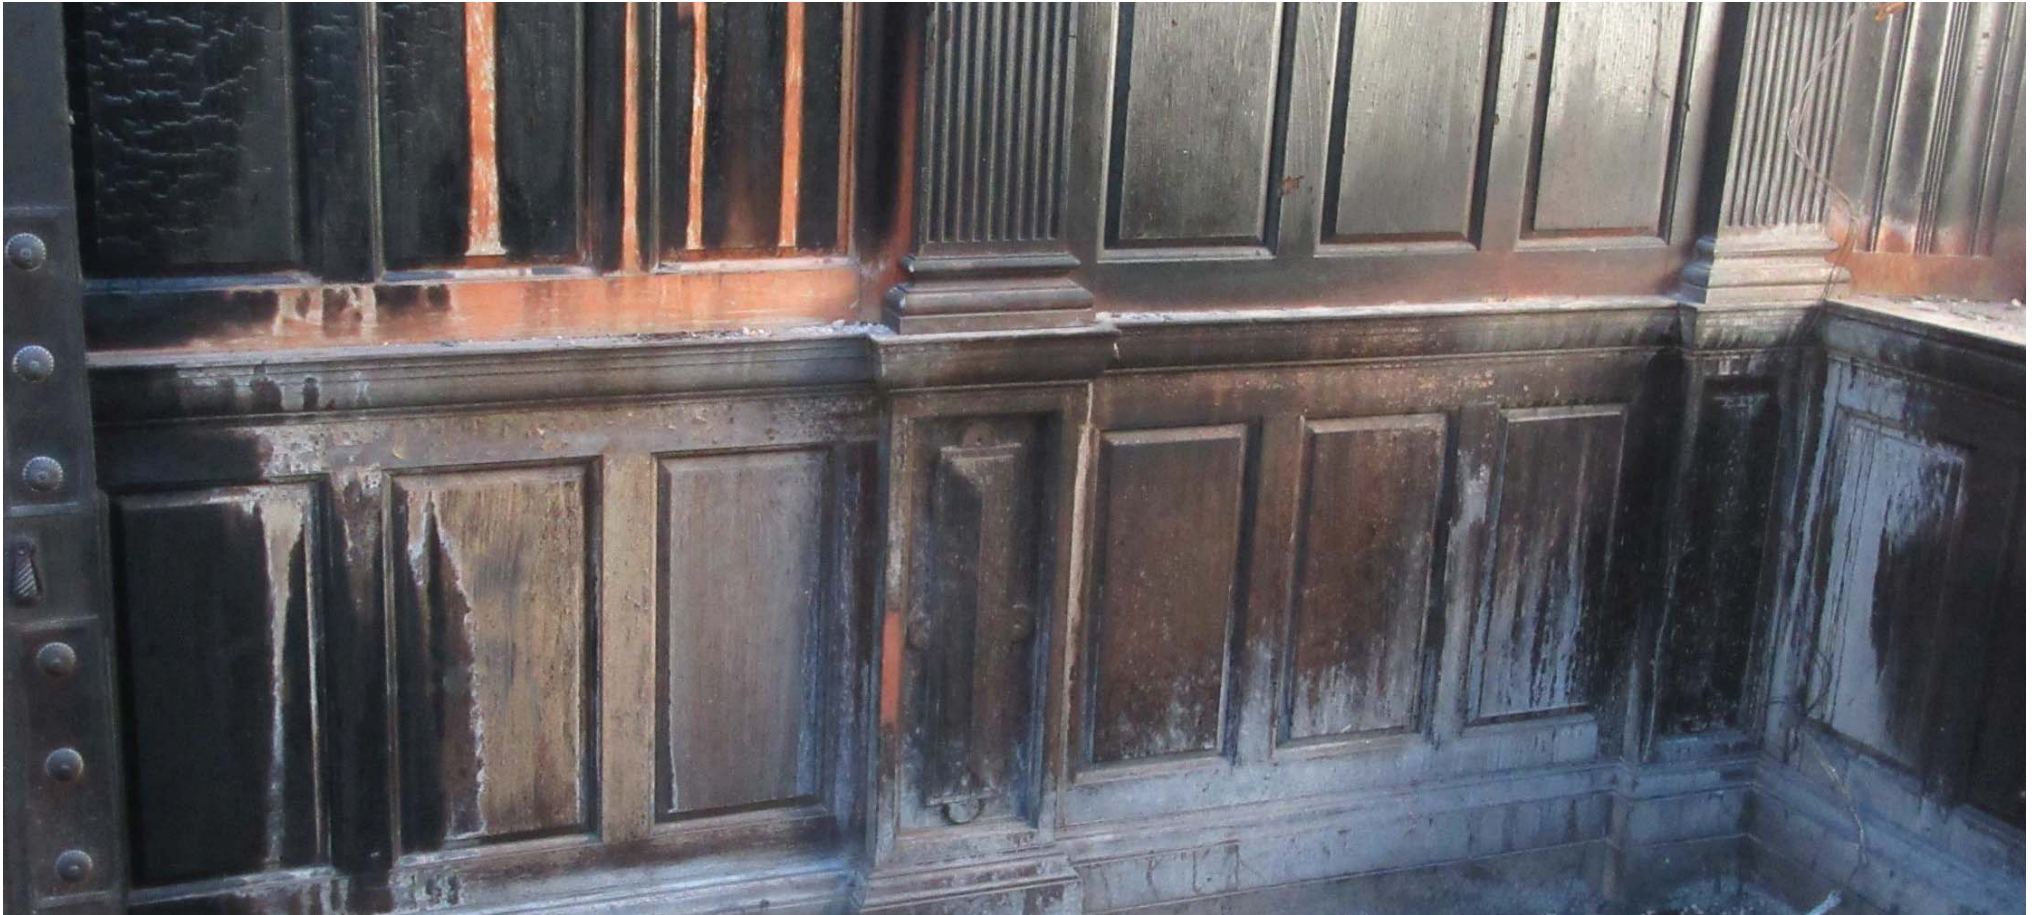
Wall Panel Condition
