BAT SURVEY REPORT

Seafield Lodge Hotel, Highland

Bat Survey Report

(August 2016)

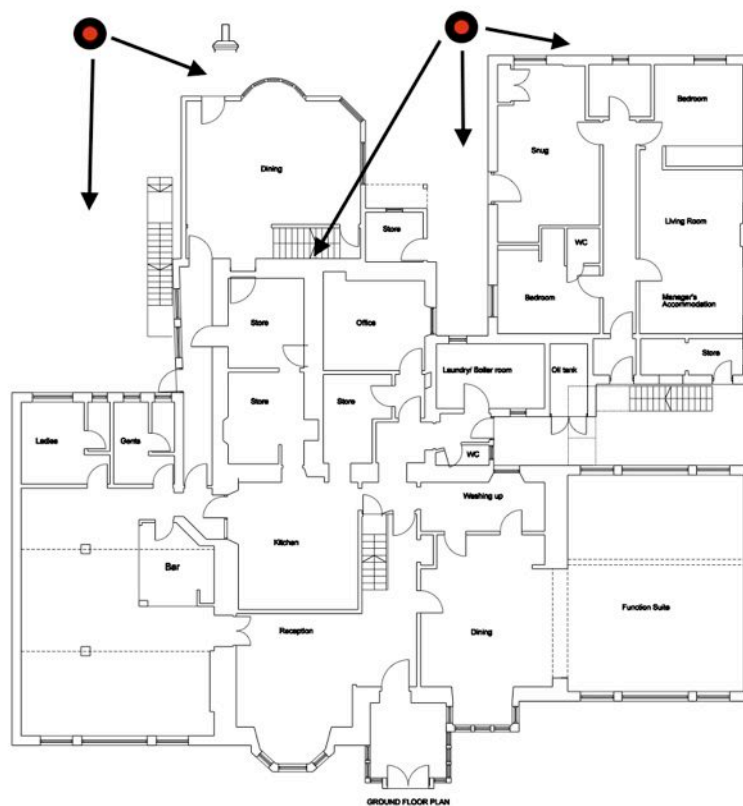
Figure 1 - Surveyor positions at Seafeld Lodge Hotel (red dots – surveyor positions, black arrows - direction of survey.)

Only two surveyors were used on the east side of the building as the west side of the building is not to be altered during the development works.

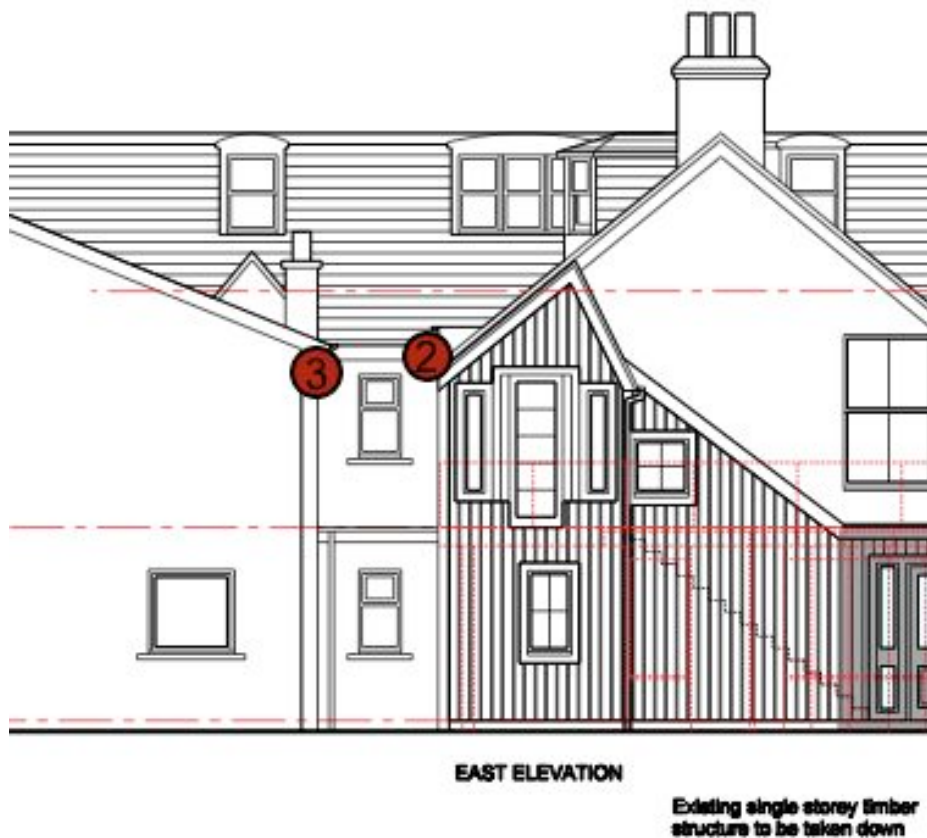
Figure 3: Proposed works adjacent to roosts 2 and 3.

There are no works directly adjacent to roost 2 and 3, the nearest is the removal of the single storey timber structure to the north and east of the roosts, which is a good 5m from the roosts themselves. The felt roof on the southeastern part of the building will have the felt replaced by slate roofing. The soffit box containing the roost will be unaffected by these works.

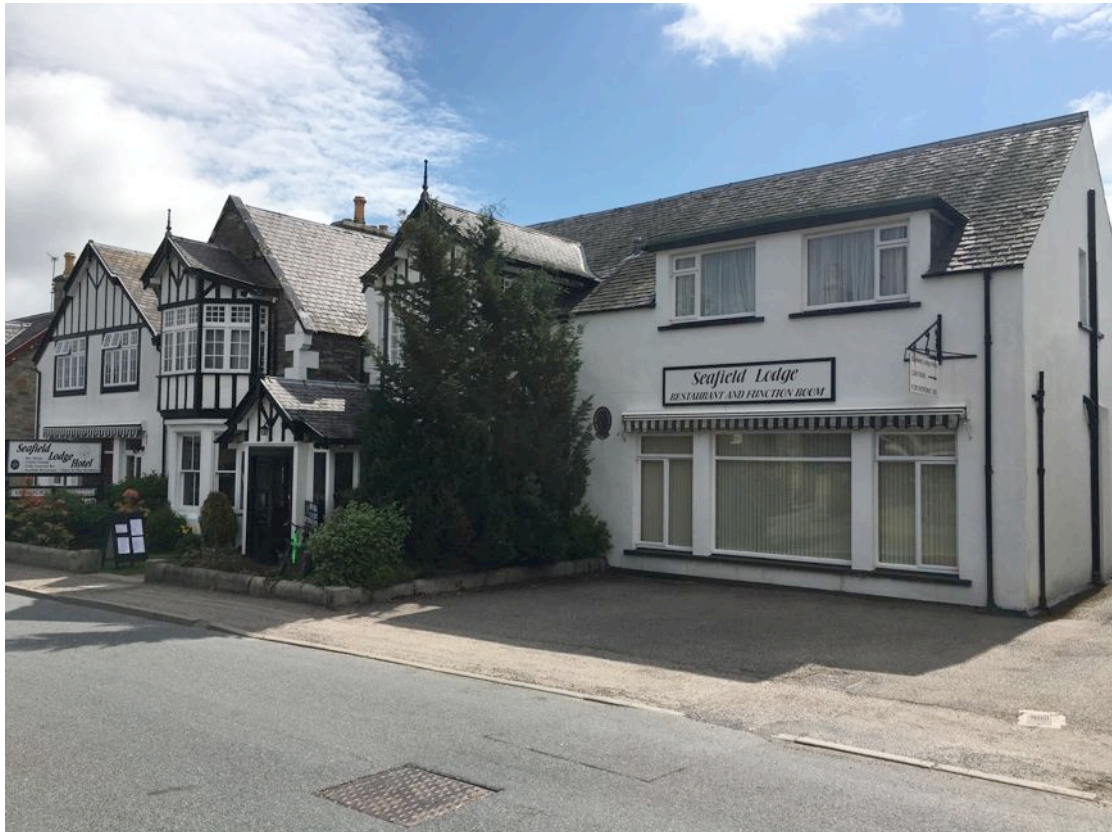
The building is unlit, however along the street on the west face there is high pressure sodium streetlighting, which will light up the whole of the western face of the building.

Photograph 1: Western face of the hotel.

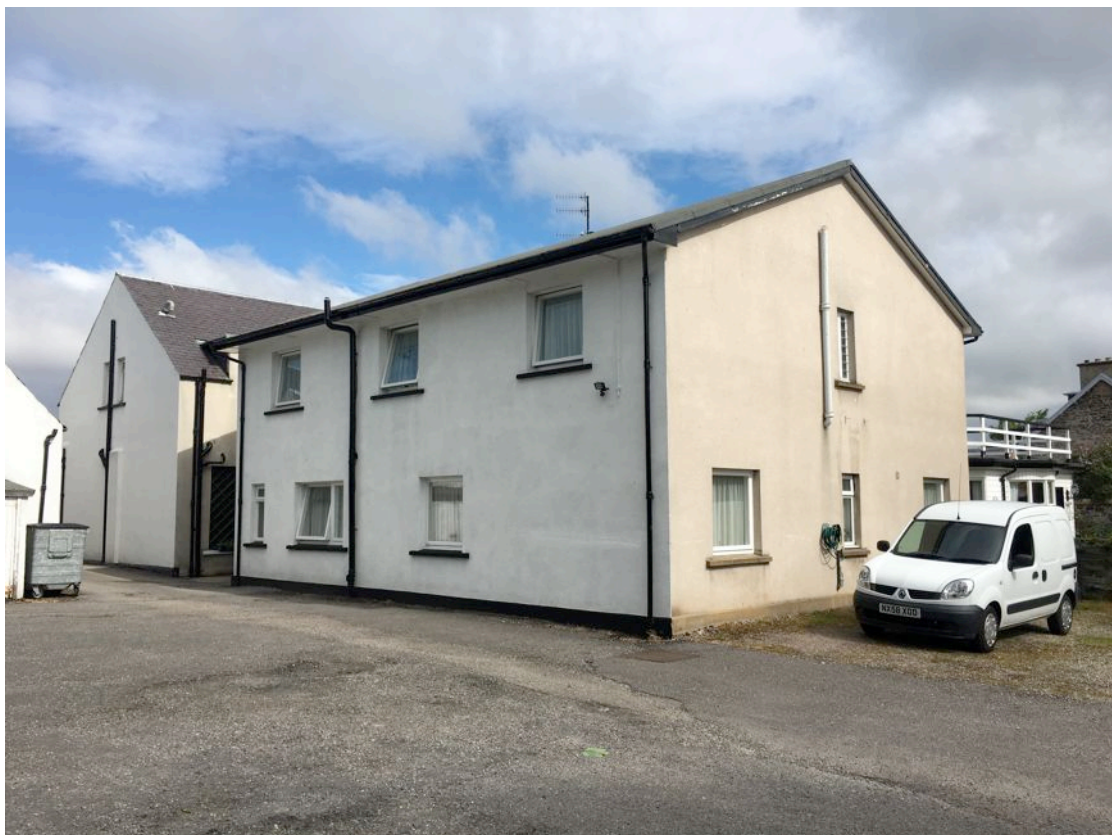
Photograph 2: Southern face of the hotel.

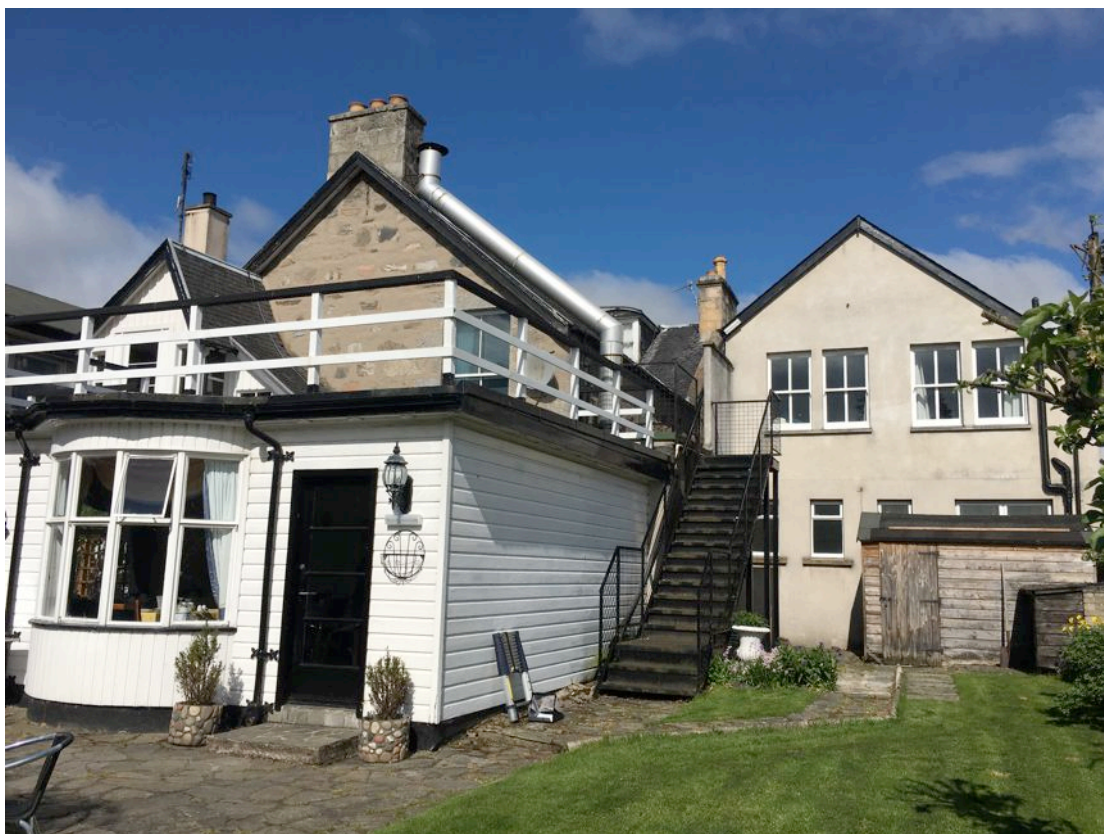
Photograph 3: Eastern face of the hotel.

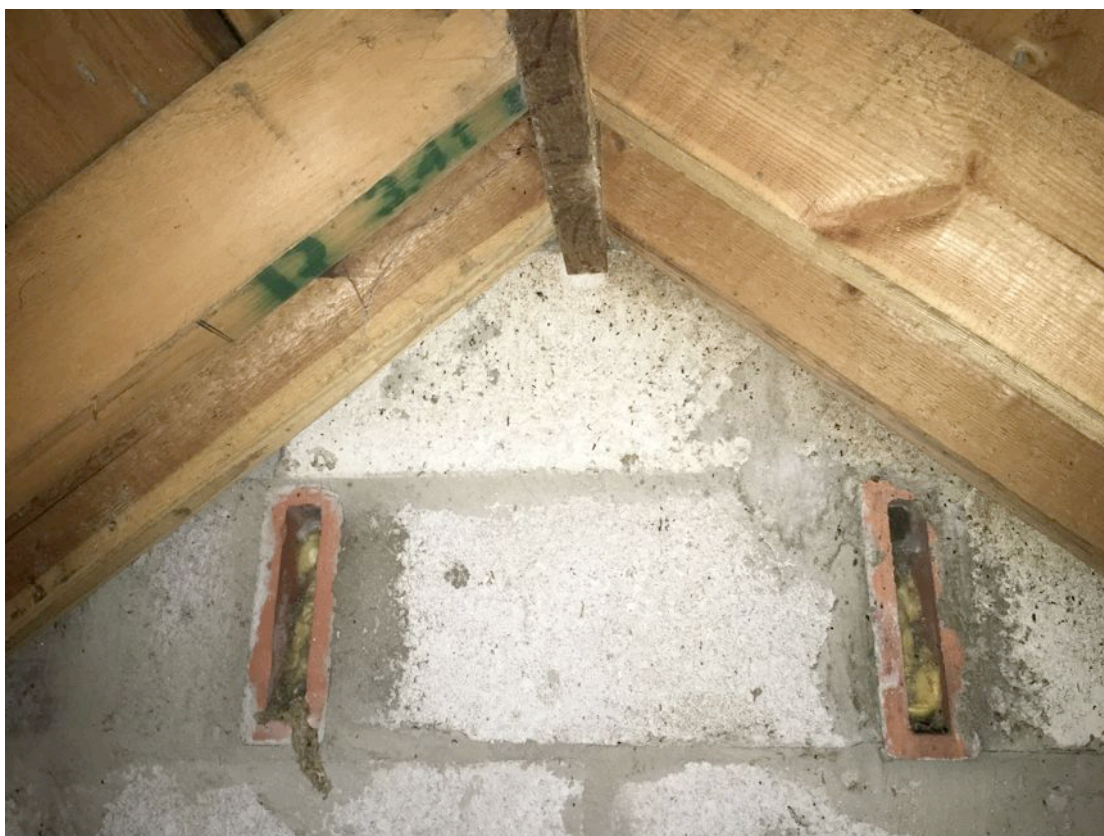
The third loft was in the north of the building above the Trout and Salmon suite. This did have evidence of bats, with 10 *Pipistrelle* sp. droppings at the west end of the loft against the gable. At the east gable there was a mass of *Pipistrelle* sp. droppings at the gable, 10-15cm deep in places. Above this there was *Pipistrelle* sp roosting between the timber and the wall, with 7 seen, but the noise suggested a lot more above the wall head. On the exterior of the loft space on the northern section of the east face, there was a gap at the apex of the gable allowing access in. There was approximately 100 *Pipistrelle* sp droppings against the gable end on the render and the windows.

*Photograph 4: Interior gable, at the north end of the eastern face of the building. Note *Pipistrelle* sp. droppings beneath timber.*

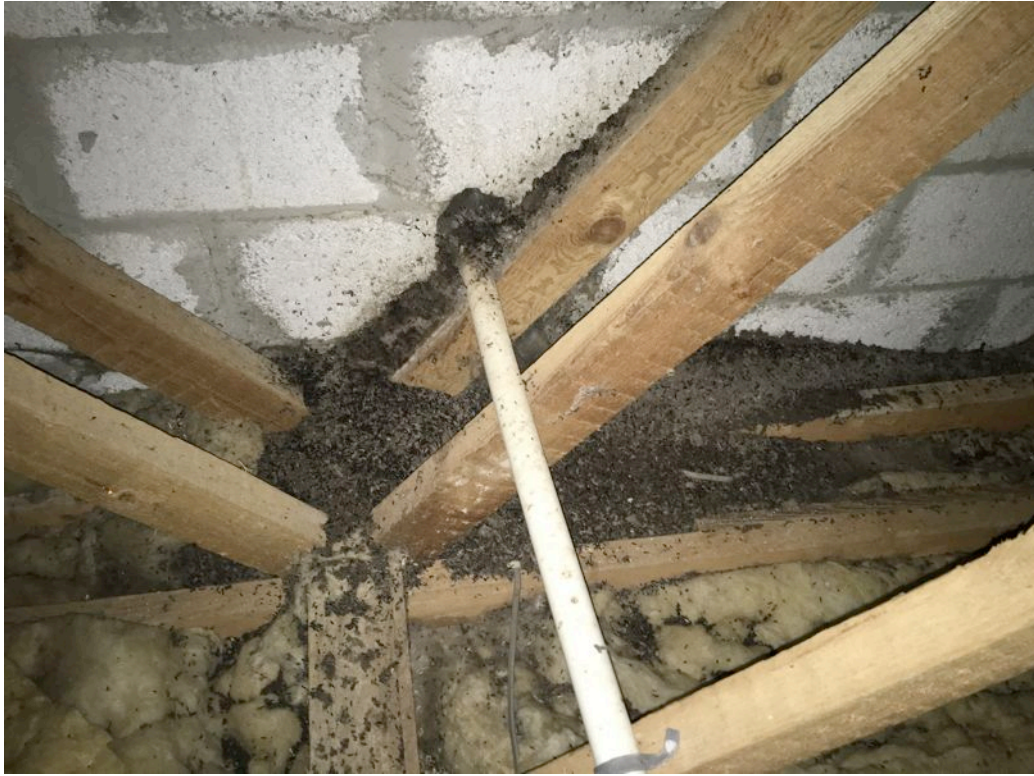
- ROOST 1 - A maternity colony of Soprano Pipistrelle roosting behind the timber on the internal gable of the northernmost loft space, at the east end. From the amount of droppings this roost has been present for several years. The exit point is on the external gable beneath a bargeboard at the apex of the gable. For the exact location see Appendix 3. Peak count of 349 on the second visit, which includes juveniles on the wing.

Photograph 5: Interior gable, at the north end of the eastern face of the building. Pipistrelle sp. droppings beneath maternity colony.

- **Deflector** - A deflector will be fitted below the external access point of Roost 1 (See Appendix 4), this would prevent the build up of droppings on the exterior of the windows on that gable of the building and prevent any complaints in the future from residents. This will be fitted under supervision of a licensed batworker.

- **Dropping removal** - The bat dropping build-up will be removed in the internal gable of the northernmost loft space, at the east end. Following removal, plasticated weatherboard will be fitted and sealed beneath the roost, to make it easier to remove droppings in the future.
- **Signage** - Roost access points will be signed with small signs, such that they are only readable when you are close to the access point. Wording as follows "This area is a protected bat roost, do not disturb. Contact Scottish Natural Heritage for more information". The northernmost loft space will also be signed internally. Signage will be installed by a licensed batworker.

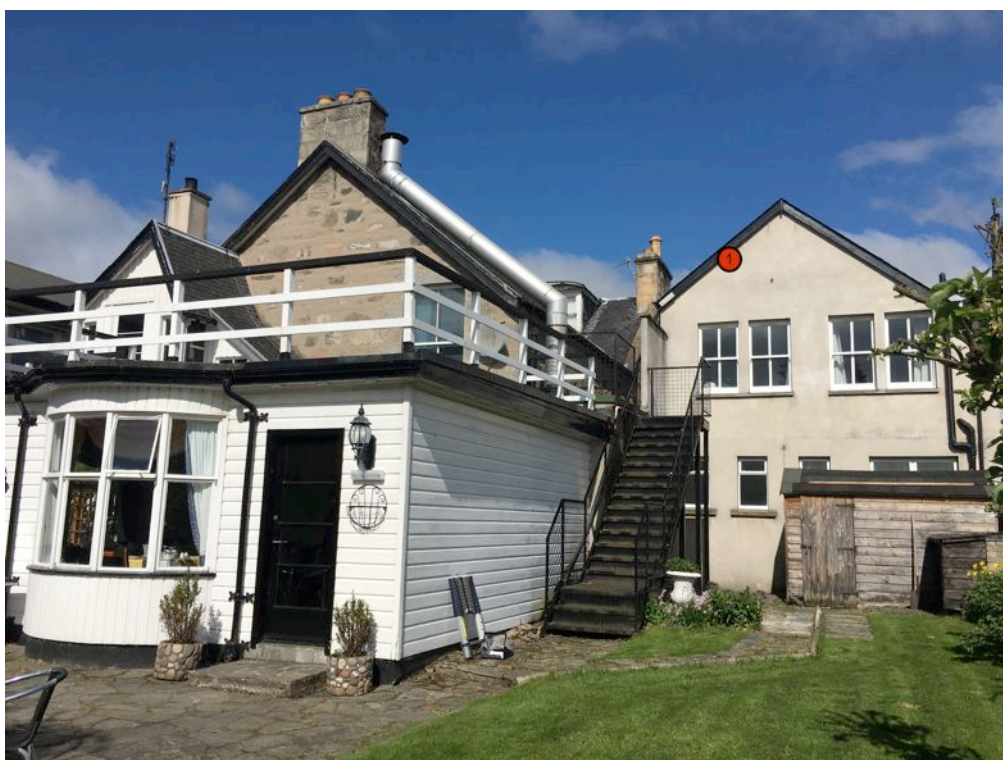
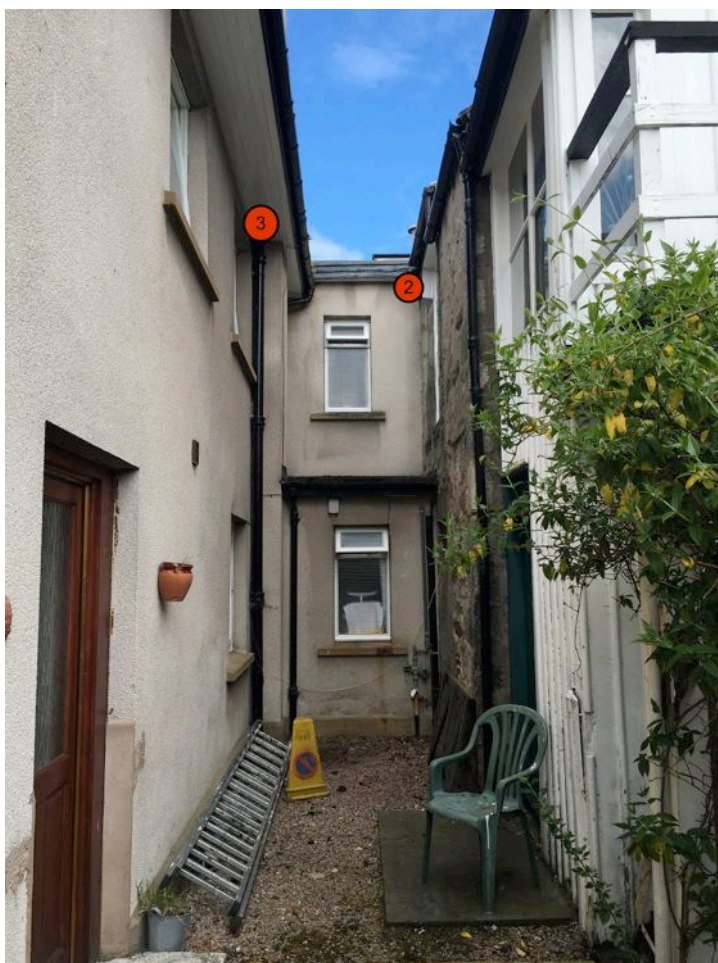
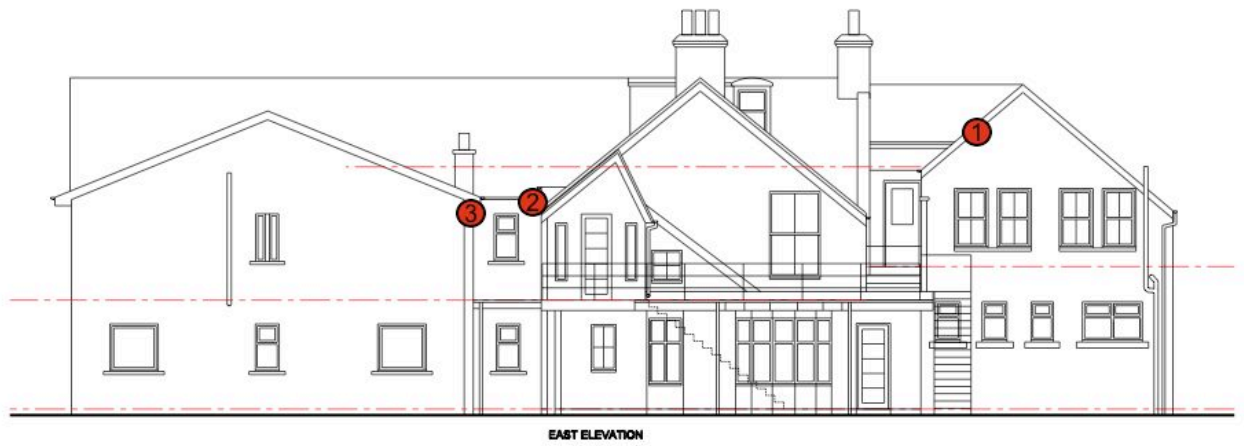
Diagrams of roost locations and access points

- ROOST 2 - A non-breeding summer roost of Soprano Pipistrelle. For the exact location see Appendix 3. This is a gap where the wall meets the roof, beneath it and against the wall were approximately 20 Pipistrelle sp. droppings. The amount of droppings would suggest a small roost or singleton bat. Peak count of 3 during the emergence/re-entry surveys.

- ROOST 3 – A non-breeding summer roost of Soprano Pipistrelle, see Appendix 3 for location. A gap behind drainage pipe where it meets soffit allows access. Droppings present in large numbers with approximately 1000 in two areas tucked behind drainpipe. Peak count of 5 during the emergence/re-entry survey, although more bats have obviously used this in the past judging by the number of droppings.

□
Eastern elevation of the Seafeld Lodge Hotel with roost locations marked and numbered.
