Upper Spey Embankment Condition Assessment

Final Report

Cairngorms National Park Authority

cbec eco-engineering UK Ltd

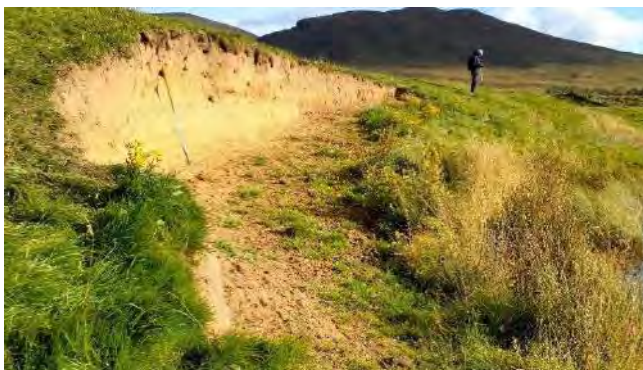
Figure 3.2 Moderate-severity riverbank erosion.

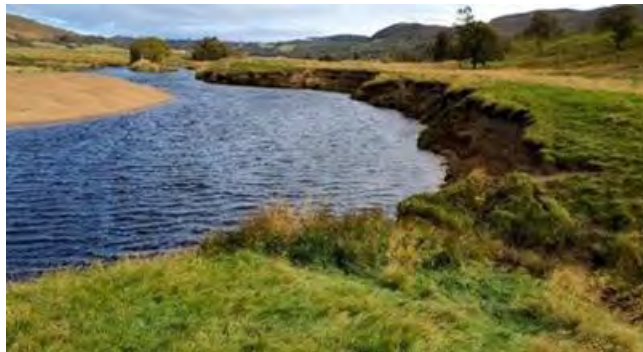
- **Channel planform.** In rivers, erosive force is focused around the outside of the meander bend, leading to natural lateral migration of the channel over time (Figure 3.8). Multiple areas of erosion around the outsides of meander bends were noted, particularly where riparian vegetation was limited. It is understood that channel adjustment, while a natural river process, may be undesirable within an agricultural setting; therefore, this erosion could be managed by undertaking riparian planting and/or fencing along the bank to improve bank stability.

Figure 3.8 Bank erosion on the outer bank of a meander is a natural process in meandering channels. Native riparian planting and set-back fencing could promote increased stability in such areas over time.

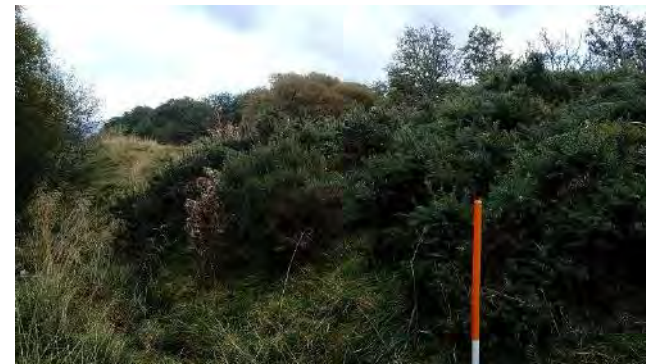
- **Scrub and young tree growth** was noted along the embankment within multiple sections of Survey Areas 1 to 3 (Figure 3.9 and Figure 3.10). In contrast to grass and ruderal flora, roots of scrubby plants penetrate deeper into the embankment, which can reduce compaction and over time destabilise the structure of the embankment. While more extensive root networks are typically beneficial for bank stability in

Figure 3.9. Scrub growth on the crest and face of an embankment.

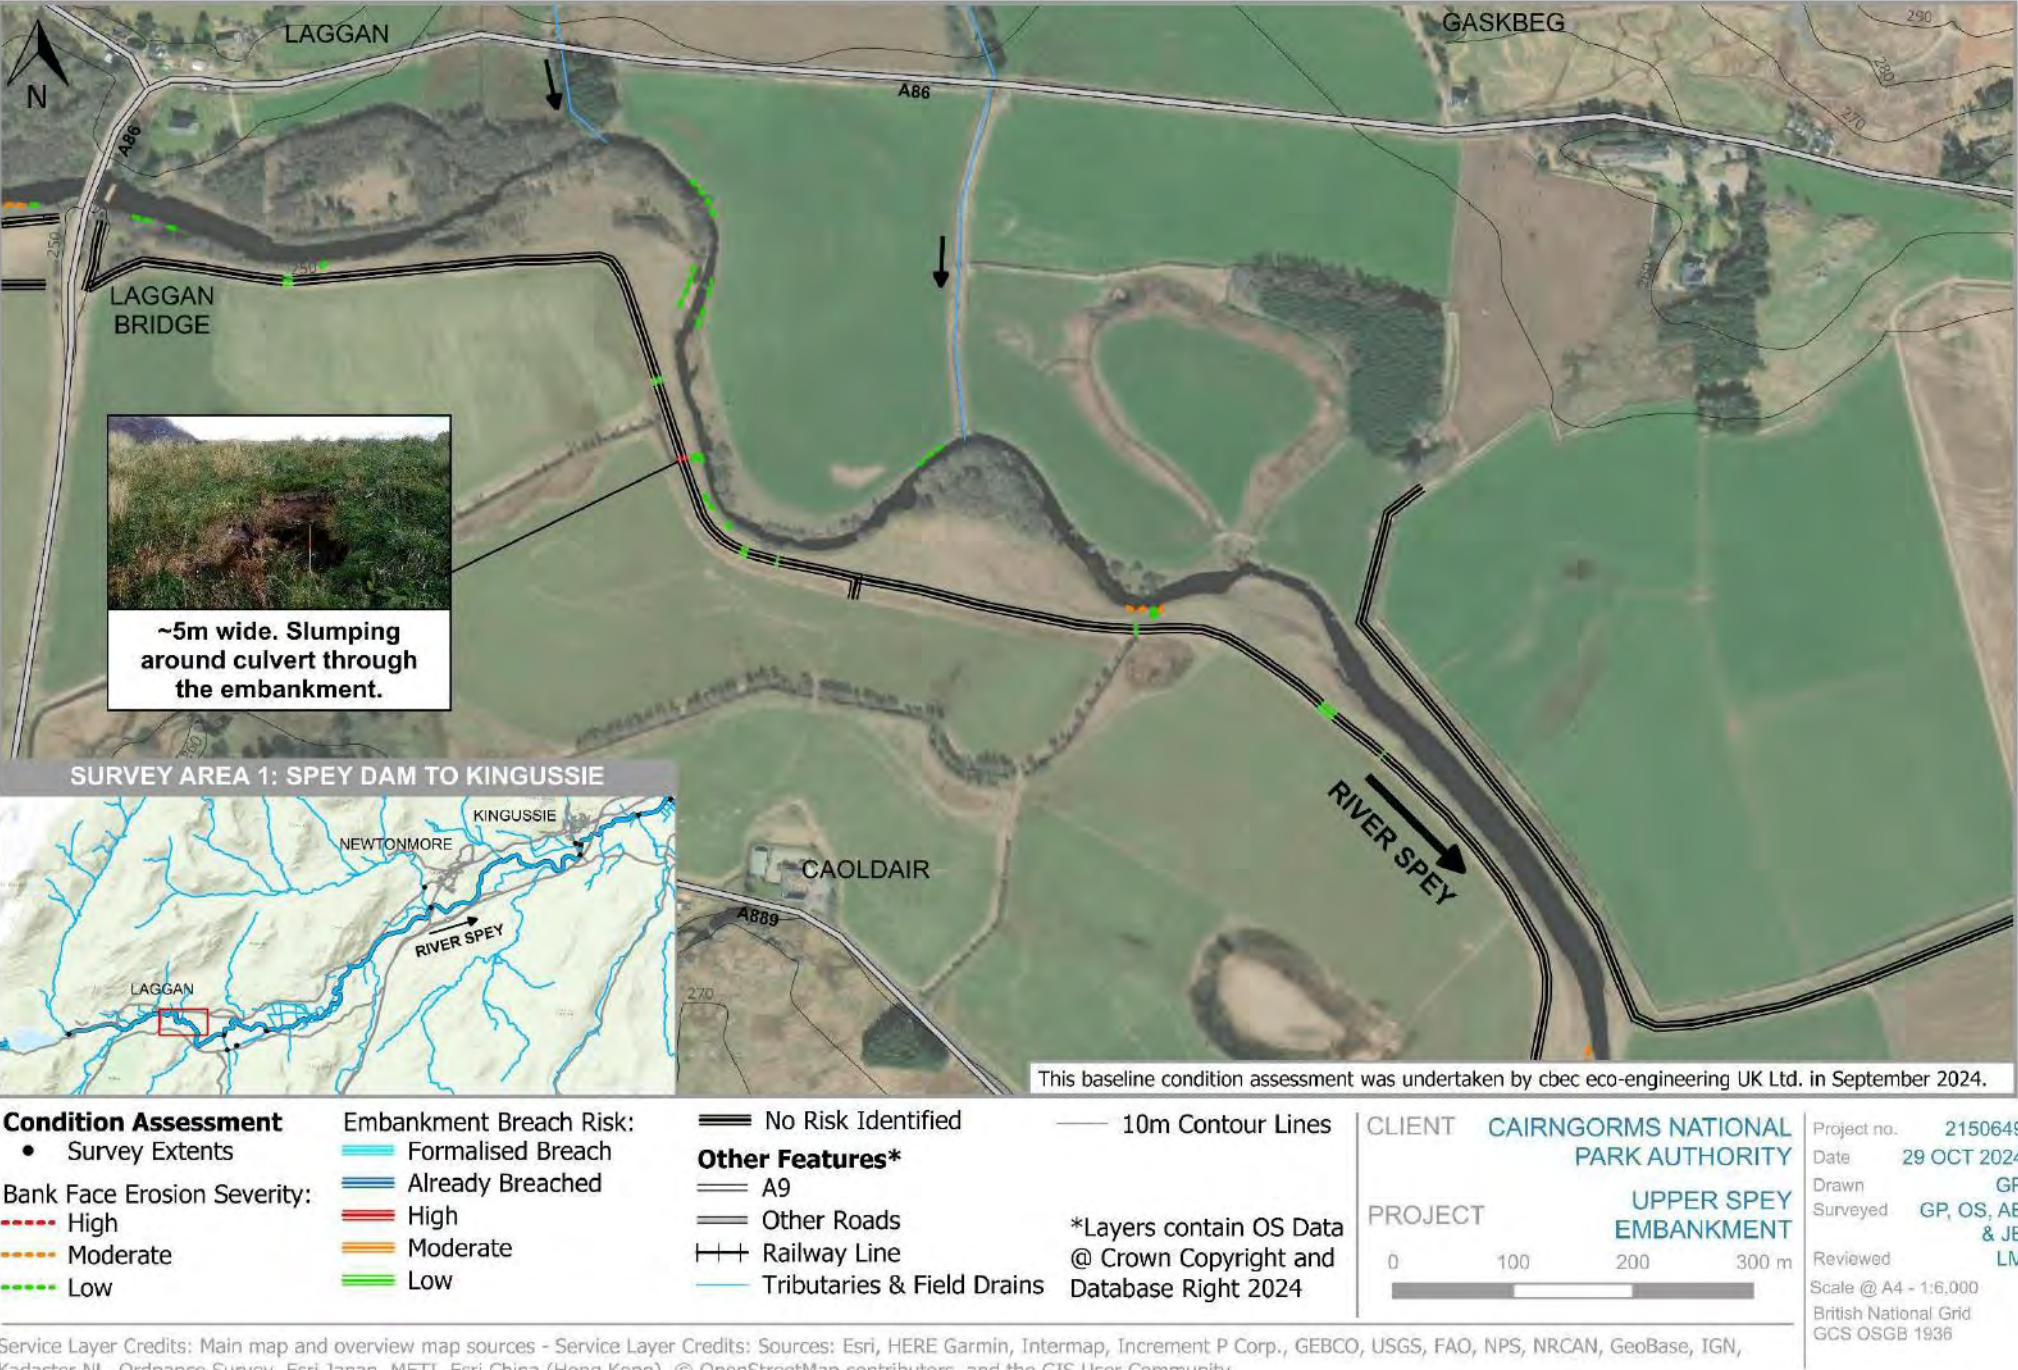
At Drumgask Farm, culverts facilitating drainage through the embankment and into the River Spey were noted in three locations, two of which were experiencing erosion with potential risks to embankment stability (Figure 3.16). Culverts through an embankment have the potential to aid surface water flow as it recedes back to the River Spey following flood events, which can help to maintain the stability of the embankment by reducing pressure caused by the water stored behind it. The drainage channel banks and the face of the embankment around these pipes were noted to be eroding at Drumgask. This erosion may be due to the volume of water and narrow size of the pipe present.

Figure 3.16 Area 1 - Map 3 showing the baseline survey results for the River Spey (Reach 1A).

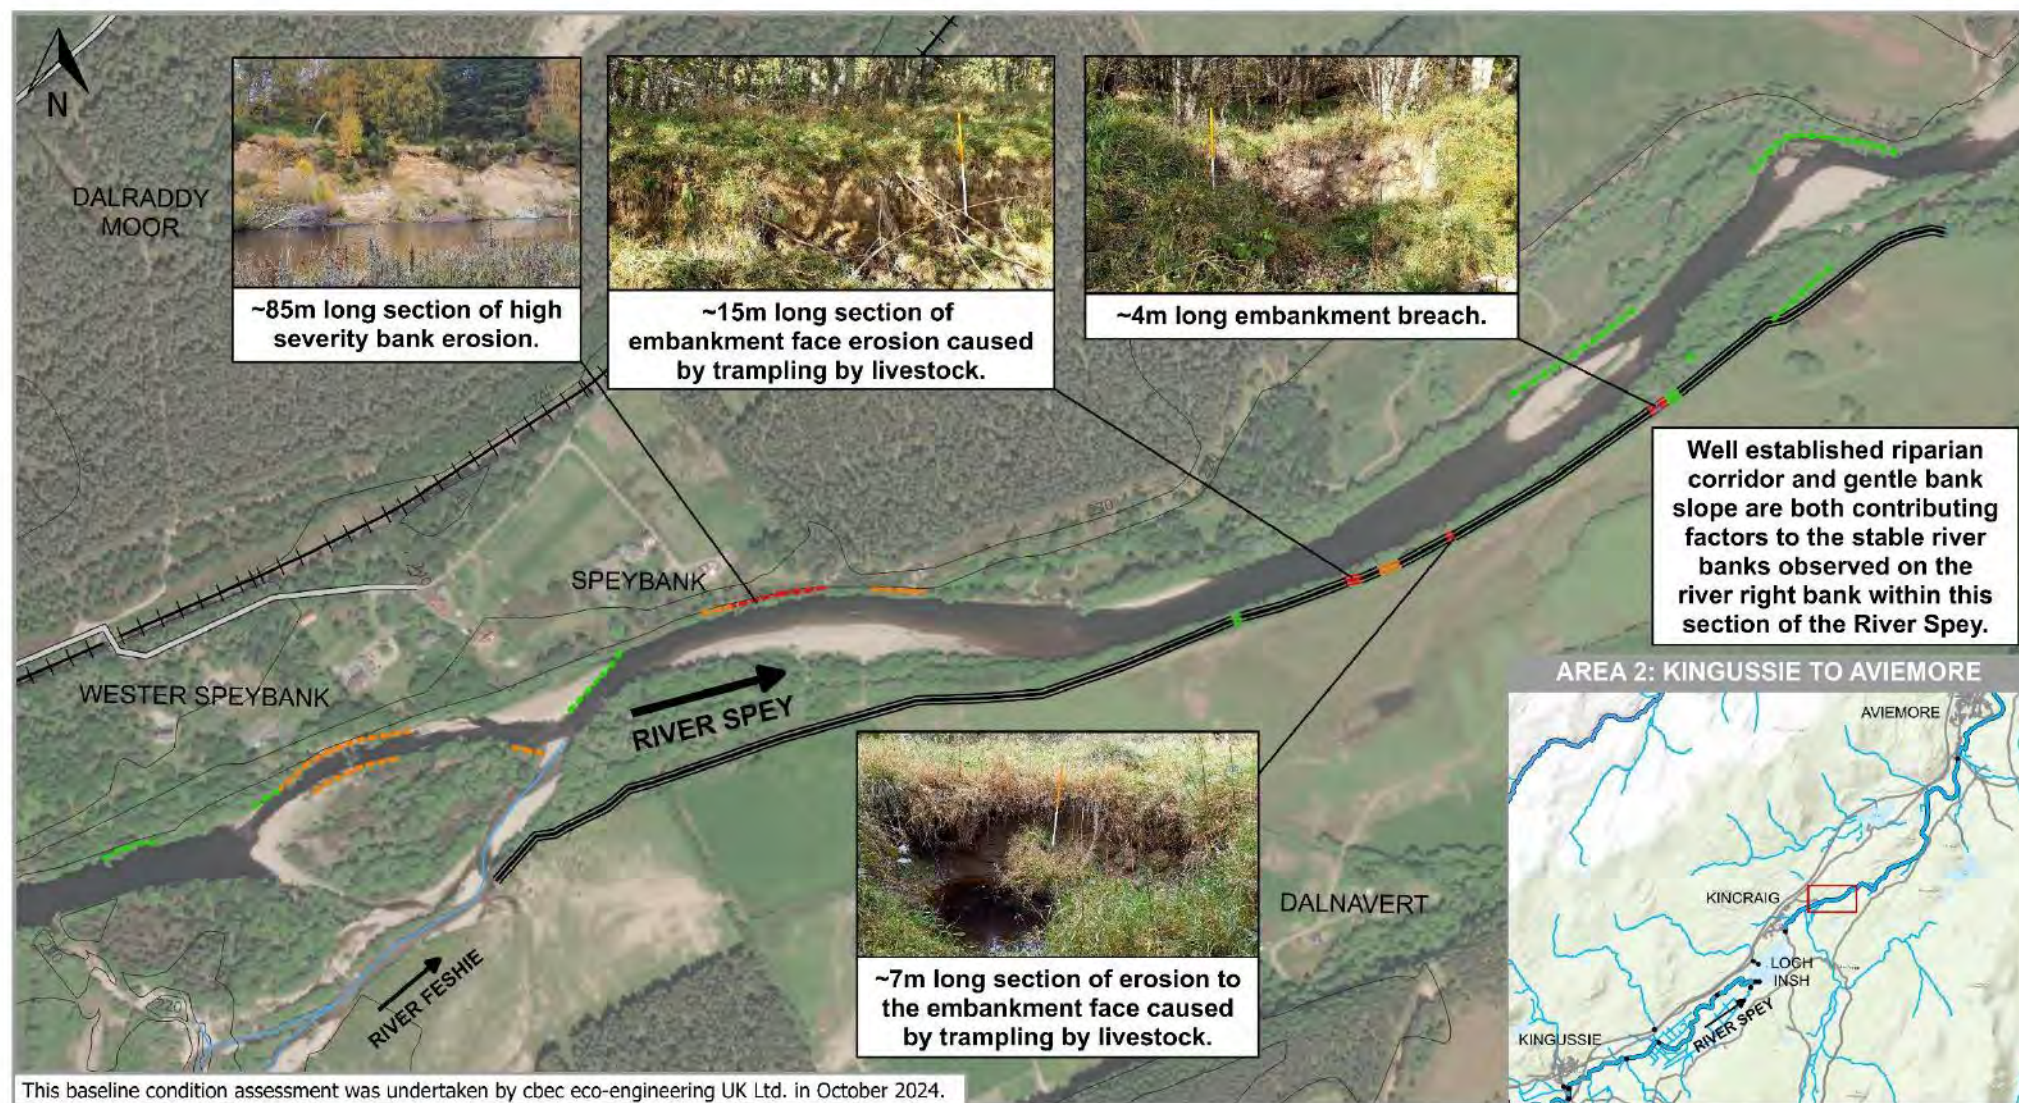
Figure 3.36 Area 2 - Map 6 showing the baseline survey results for the River Spey (Reach 2G).

Downstream of Loch Insh, the River Spey was surveyed from Kincaig downstream to the B970 bridge on the southern side of Aviemore (Reach 2G; Figure 3.36 to Figure 3.42). Steep banks are present on the river left (western) side of the Spey throughout the first ~2.3 km of this section, with moderate- to high-severity erosion recorded between Wester Speybank and Speybank, owing to the height and sheer face of this part of the bank. Throughout the remainder of this reach, the riverbanks were found to be well vegetated, with a combination of ruderal vegetation and tree cover within the riparian corridor. Resultant of the vegetation cover and gentle gradient, most of the riverbanks within Reach 2G were classified as exhibiting low-severity or no erosion, not deemed to be significant enough to pose a threat to the embankments. Occasional moderate- to high-severity erosion was noted in

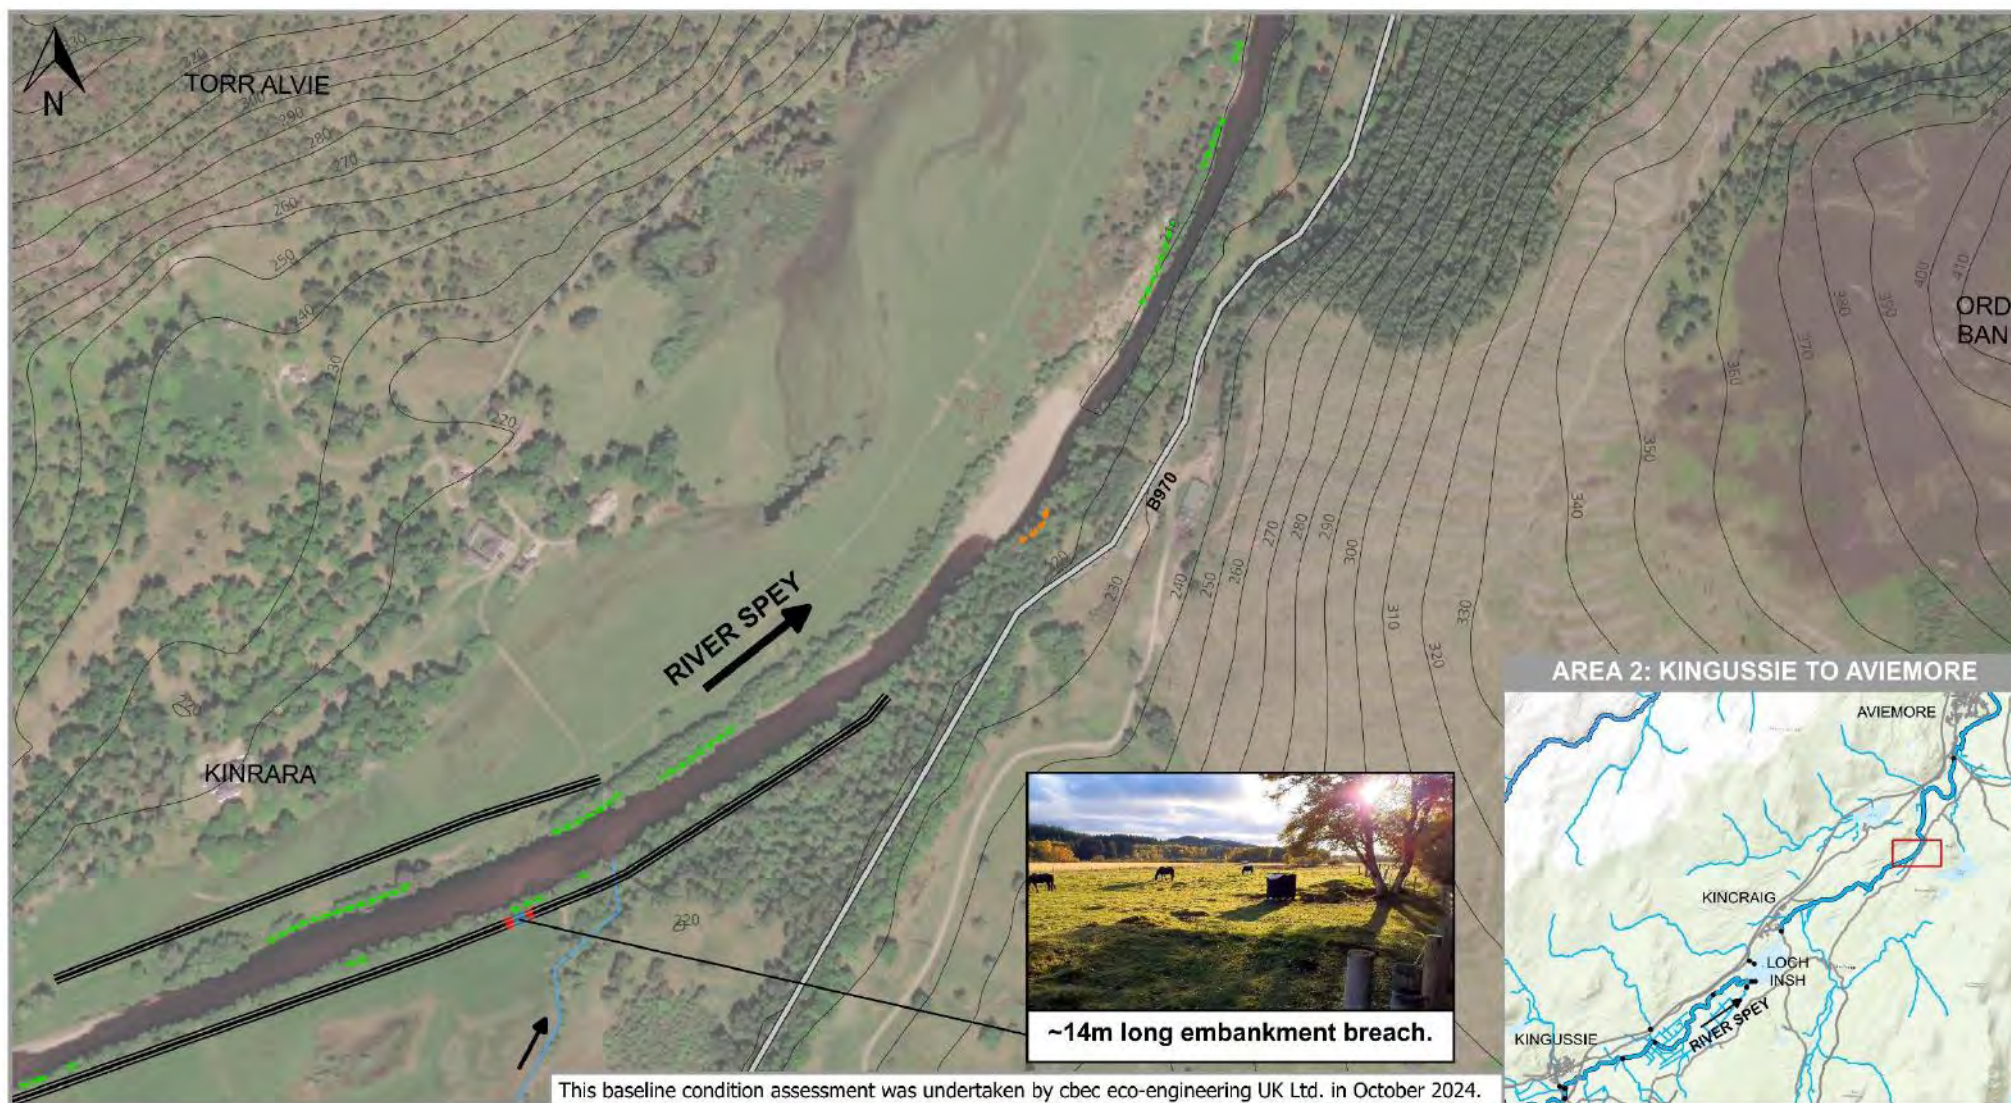
Figure 3.38 Area 2 - Map 8 showing the baseline survey results for the River Spey (Reach 2G).

localised areas, particularly around the outside bends of meanders, with embankments rarely impacted (Figure 3.38, Figure 3.40 and Figure 3.41).

Embankments on the left bank were rare throughout Reach 2G, with occasional sections noted around Kinrara (Figure 3.38 and Figure 3.39) and from the Allt-na-Criche confluence to Aviemore (Figure 3.41 and Figure 3.42). Slumping due to degradation of the embankment condition and trampling by livestock were noted to be the main factors influencing the risk of embankment breach within this reach. Trampling of the embankment by livestock in the lower section of Reach 2G, between Doune Farm and the Milton Burn confluence, was concentrated around mature trees. Livestock lying around, sheltering beneath or rubbing against these trees has led to increased footfall over these sections of the embankment, lowering the crest height and increasing the vulnerability of these areas to breaching. Erection of fencing along the riparian corridor would prevent livestock access to this area, allowing the embankment time to revegetate and increasing the sustainability of any remedial works undertaken.
